Faulting, Afterslip and Deformation Associated with the 24 August 2014 South Napa Earthquake (M 6.0)

Ken Hudnut, Ph.D. - U. S. Geological Survey

California Spatial Reference Center Semi-Annual Meeting
Ontario, California
1 October 2014

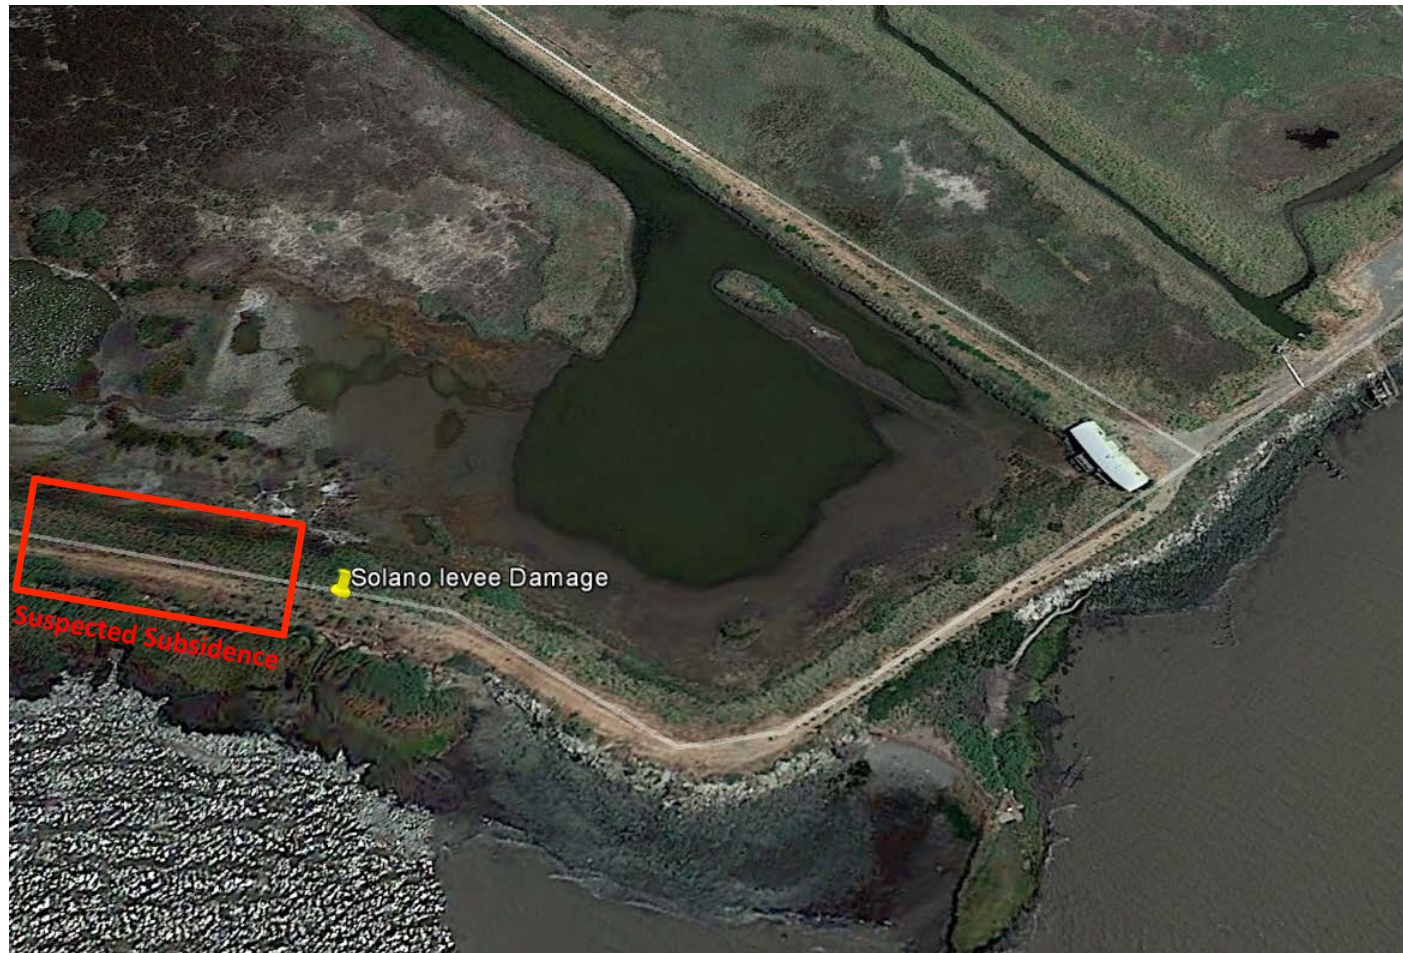
Looking NW from repaired location at suspected subsidence area
needs further inspection
